FACILITY COMPLIANCE INSPECTION REPORT

Division of Waste Management Solid Waste Section

Miller Farm LCID Landfill Miller Farm Road Morehead City, NC 28557

N0190-20120315INSP

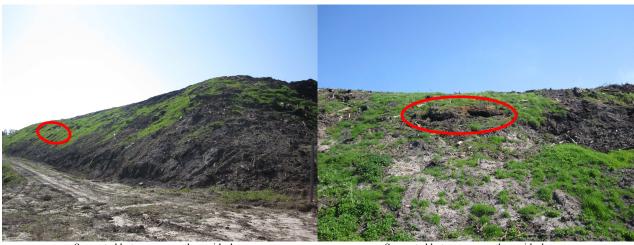
- 15) The operator has compacted, graded, and seeded all landfill sideslopes. A cover crop has begun germinating throughout the landfill.
- 16) Two small areas, one located approximately halfway down the northern sideslope, midway up from the toe; and the other, on the southern sideslope, approximately fifteen yards from the southwest corner marker, midway up from the toe, still appear to be hot. Small settled areas were noted in these two locations and the newly germinated cover drop around these sinks exhibited signs or heat stress. A small amount of smoke was observed emanating from the sink on the northern sideslope. *As soon as is **safely practicable**, please resume compacting and covering the landfill cap and sideslopes in these areas. Once the repairs are completed, all sideslopes should be graded at a slope not greater than 3:1 and seeded and mulched to establish a groundcover suitable to prevent erosion.

Suspected hot area on northern sideslope

Suspected hot area on southern sideslope
